St. Clement's Church,
Jersey

Report on the Feasibility Tests for the Restoration of Wall Paintings.

ST. CLEMENT'S CHURCH - JERSEY

WALLPAININGS INSPECTION

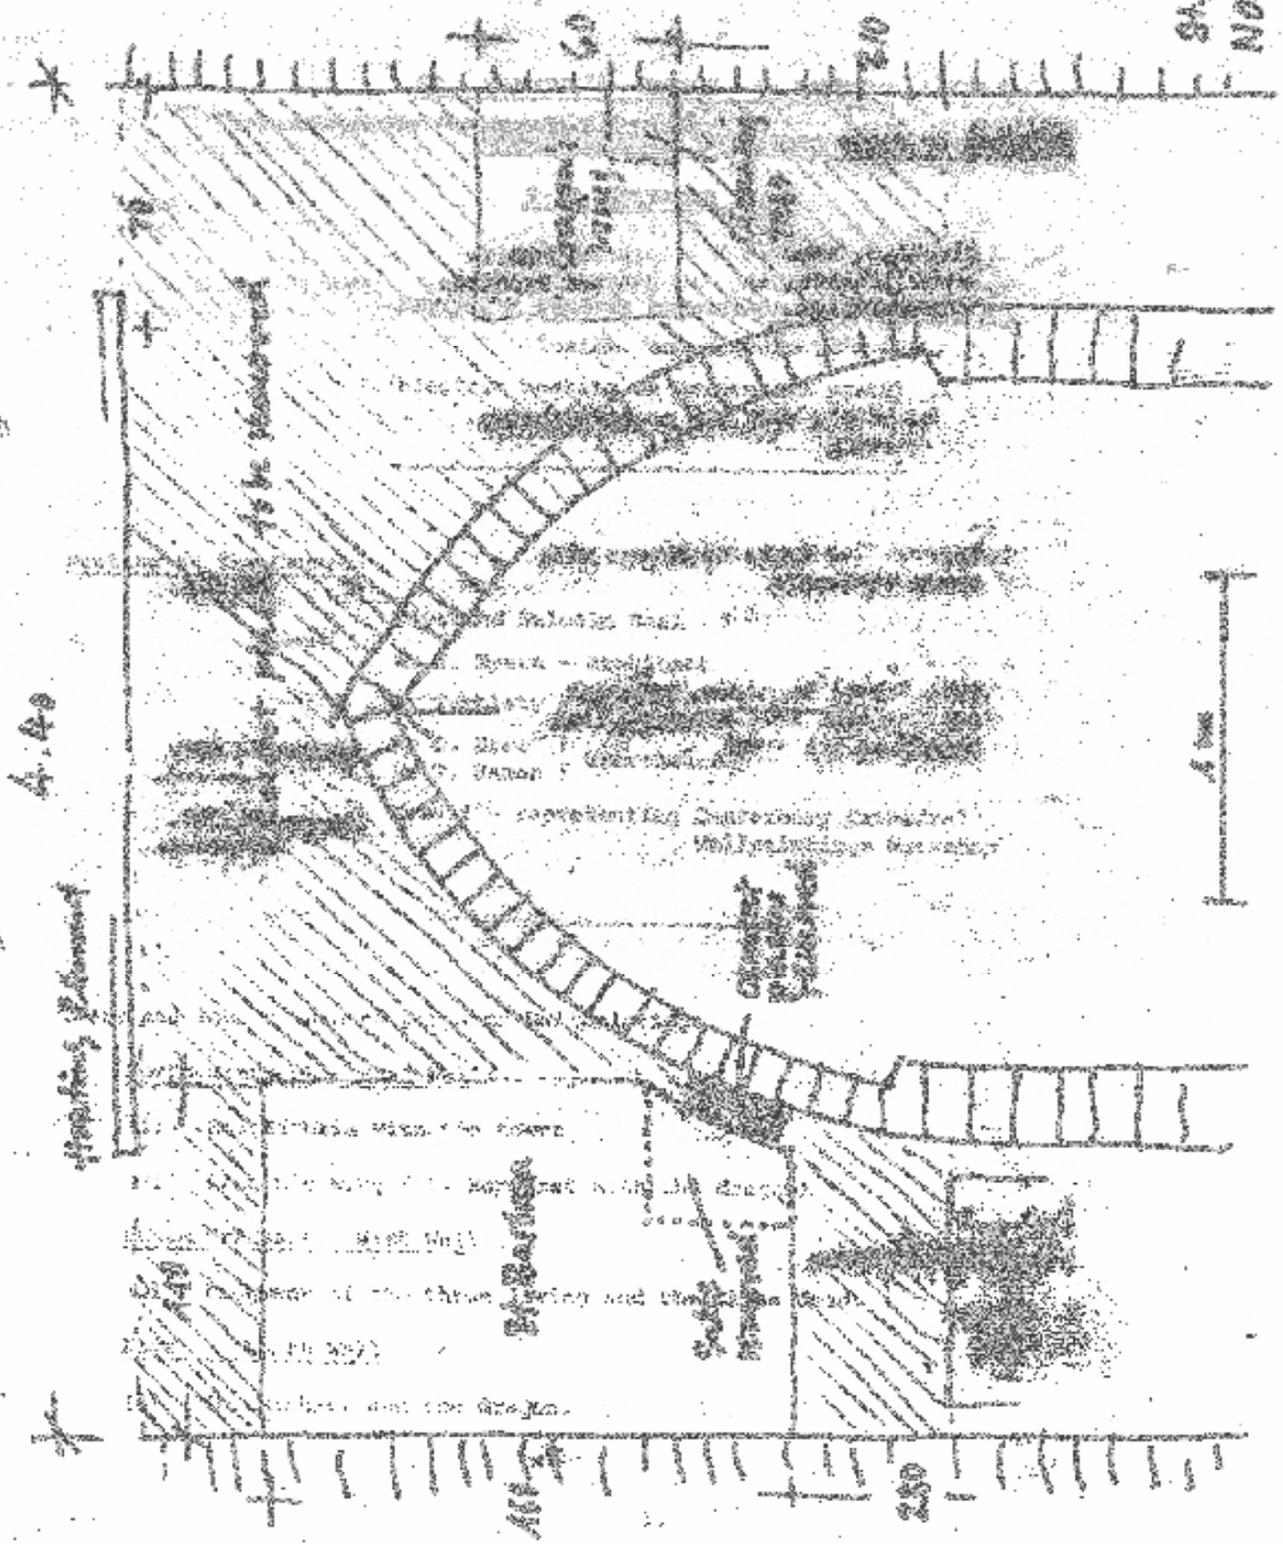
SACRAMENT'S
NORTH TRANSEPT

In the North Transept the cement plaster around the arch and the murals should be removed as indicated on the sketch (ideally on both sides of the wall).

Faulty plaster repairs and overpaintings within the paintings should be removed, together with consolidation of endangered original plaster and paint.

The now square appearance would disappear and the fragments reduced to its original irregular shape.

It may well be acceptable to leave the surrounding stripped area unplastered looking like an Arriccio. At least it has to be left unplastered for some time.
